SAN ISIDRO GOLF CLUB
SAN ISIDRO (1634) - BUENOS-AIRES - ARGENTINA

SITE REPORT FOLLOWING VISIT IN OCTOBER 07

A D A M G O L F D E S I G N
ARQUITECTOS DE CANCHAS DE GOLF

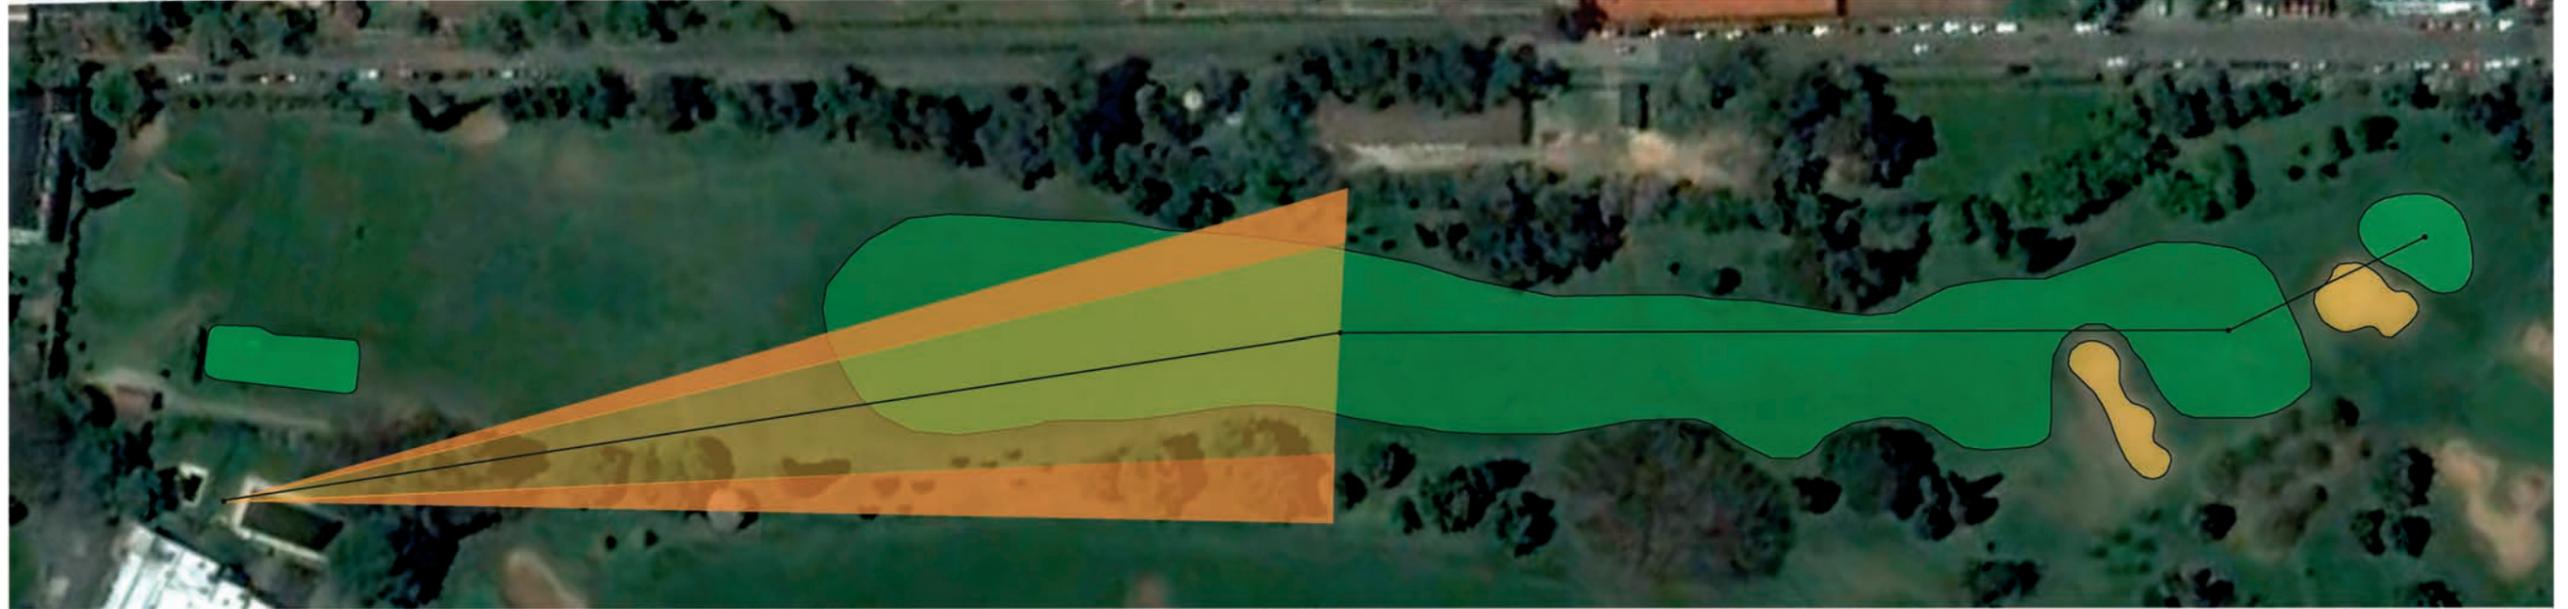
HOLE N° 1

I quickly analyzed a proposition from a board member, notably the positioning of the men's tee at the location of the existing swimming-pool. As one can see from the drawing above, this option would bring about the removal of numerous trees and would pose a major safety problem for players on the hole n°9. Moreover this proposed positioning of the men's tee does not significantly enhance the quality of hole n°1, nor alter significantly the playing conditions and length on the practice facility. I strongly recommend that the club abandon this option.

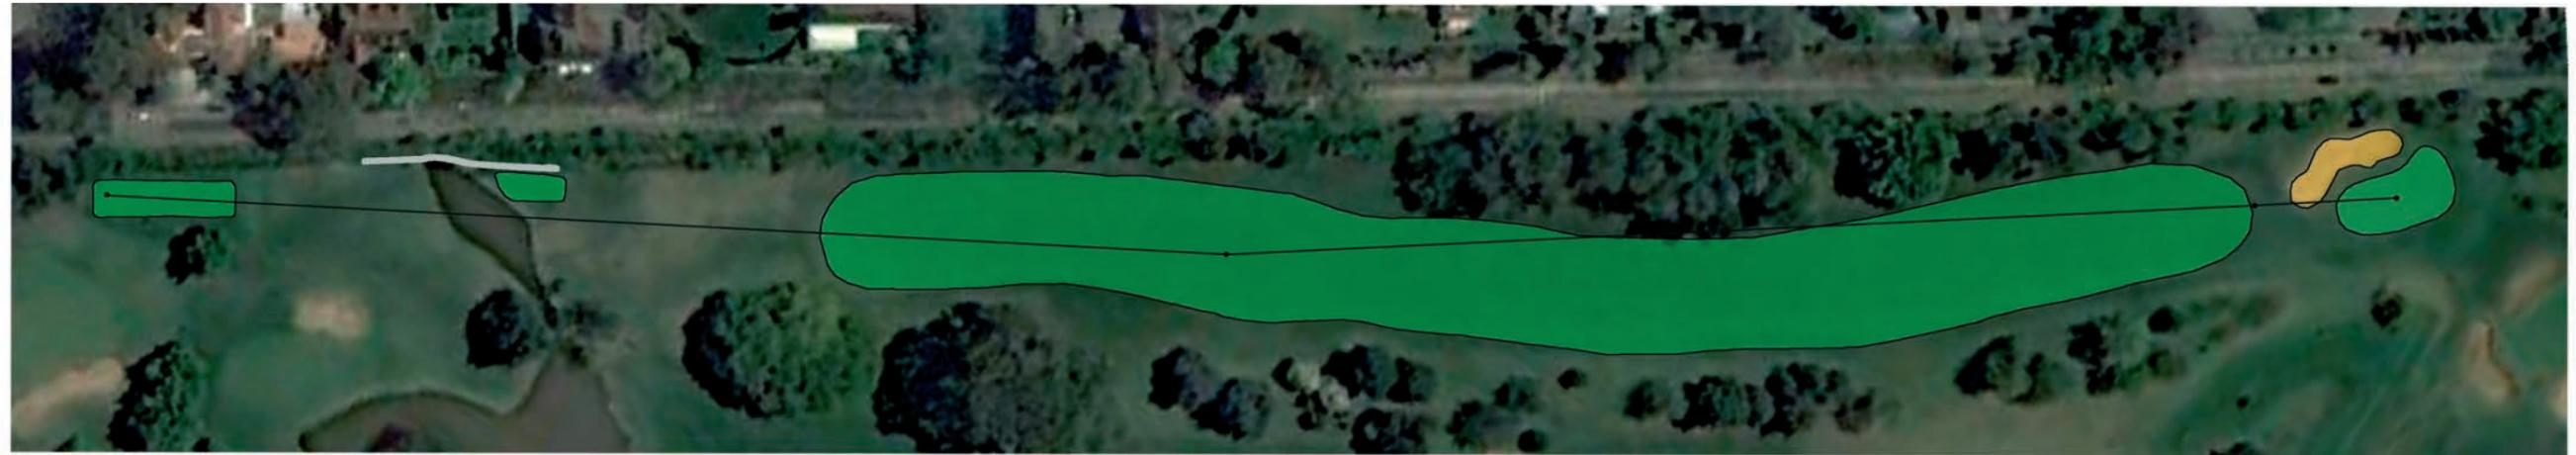
EXISTING

On this hole we have tried to correct and ameliorate an important safety concern with regards to the road. Within the proposed drawing we are suggesting to shift the center-line of play more towards the right portion of the fairway and to enlarge the fairway on the right hand side by removing a tree and a bush. The tee boxes have been re-aligned in the same direction as this center line. We are proposing that some dense planting be put in place alongside both the existing men's and ladies tees. The positioning of this vegetation as the ball rises from the tee rather than at the end of its flight has been shown to be more effective both physically and psychologically. With regards to the tees themselves we are proposing several options. Firstly to lower the men's tee which we strongly recommend. If the membership were to be opposed to this idea, a new tee just in front of the existing and close to ground level has been proposed. This however maintains the back tee for championship golf. In order to afford protection to players on this new tee from play on hole n° 14, we propose the planting of two trees. The ladies tee would be slightly changed in order to allow the repositioning of the cart-path.

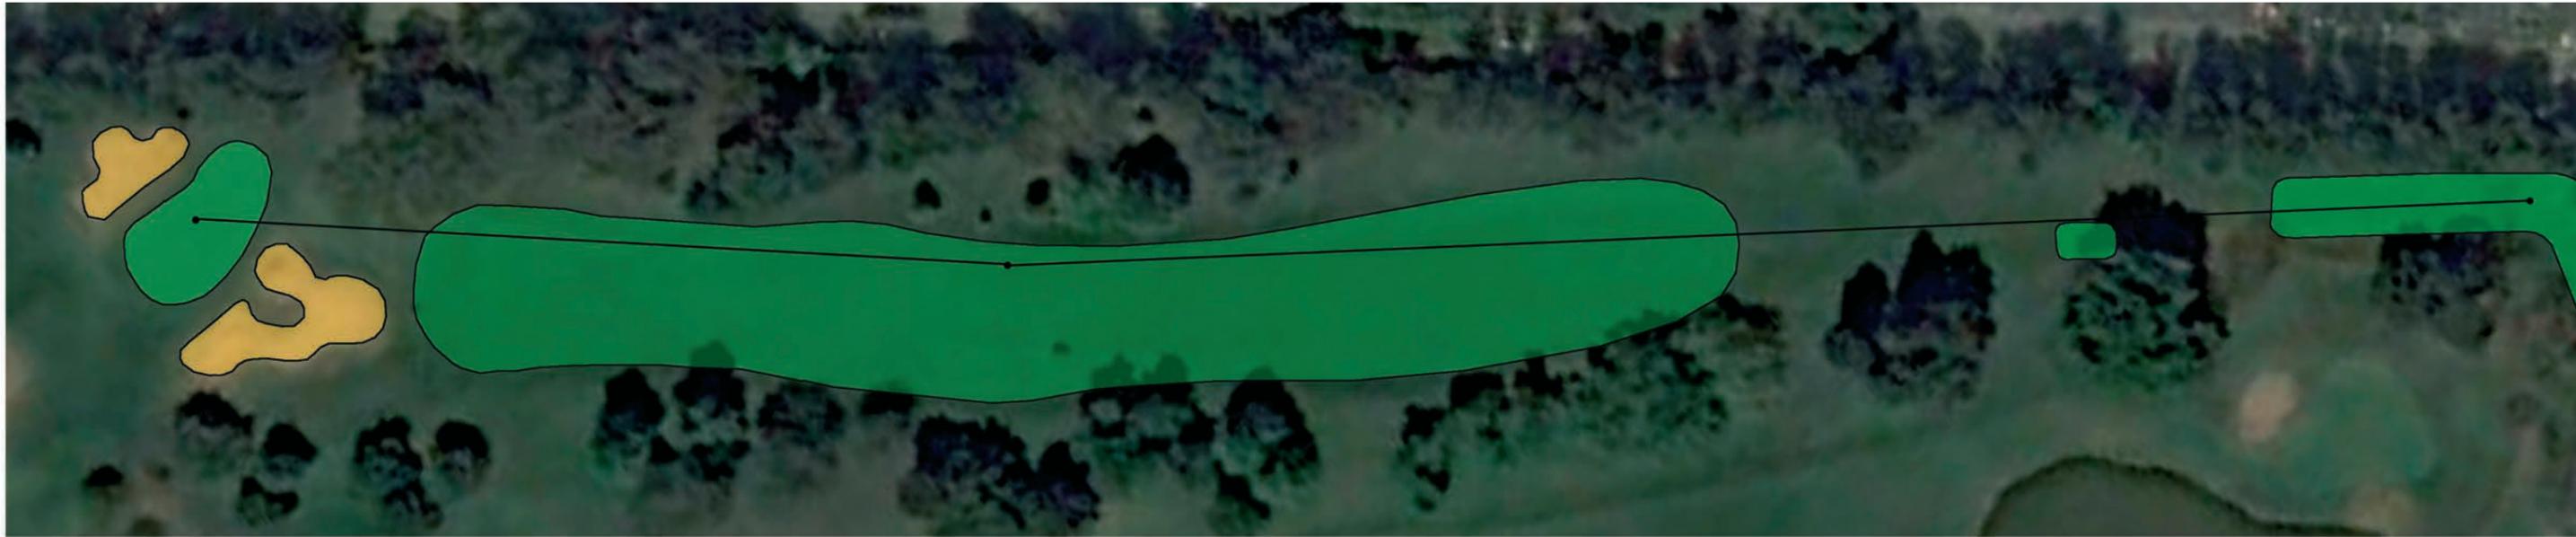
EXISTING

On this hole the tee alignment sets up the player to play down the right hand edge of the fairway, which also increases the possibilities of balls going onto the road. We propose to shift the center-line of the hole more to the left and to re-align the tee box accordingly. We believe that this measure will enhance the hole and help to reduce the number of balls going onto the road. With regards to the second shot, we strongly recommend that you conserve the magnificent tree next to the green on the right. According to the pin position, the difficulty and type of shot varies. With the pin on the right hand side, the player should consider a pitch and run shot, whilst with the pin on the left, a lob shot is needed. Another concern on this hole was the visibility of the whole green and particularly the left hand side from the landing area. We propose to lower the edge and lip of the bunker after the irrigation line and to very slightly reduce the size of the existing bunker. This action will permit the visibility of the left hand side of the green as can be seen from the photos below. Nevertheless we propose that the middle part of the green remain blind, so as to present a very difficult pin position that could be used during championship play. The players will find it hard to correctly estimate the depth of the green or the proximity of the pin to the bunker.

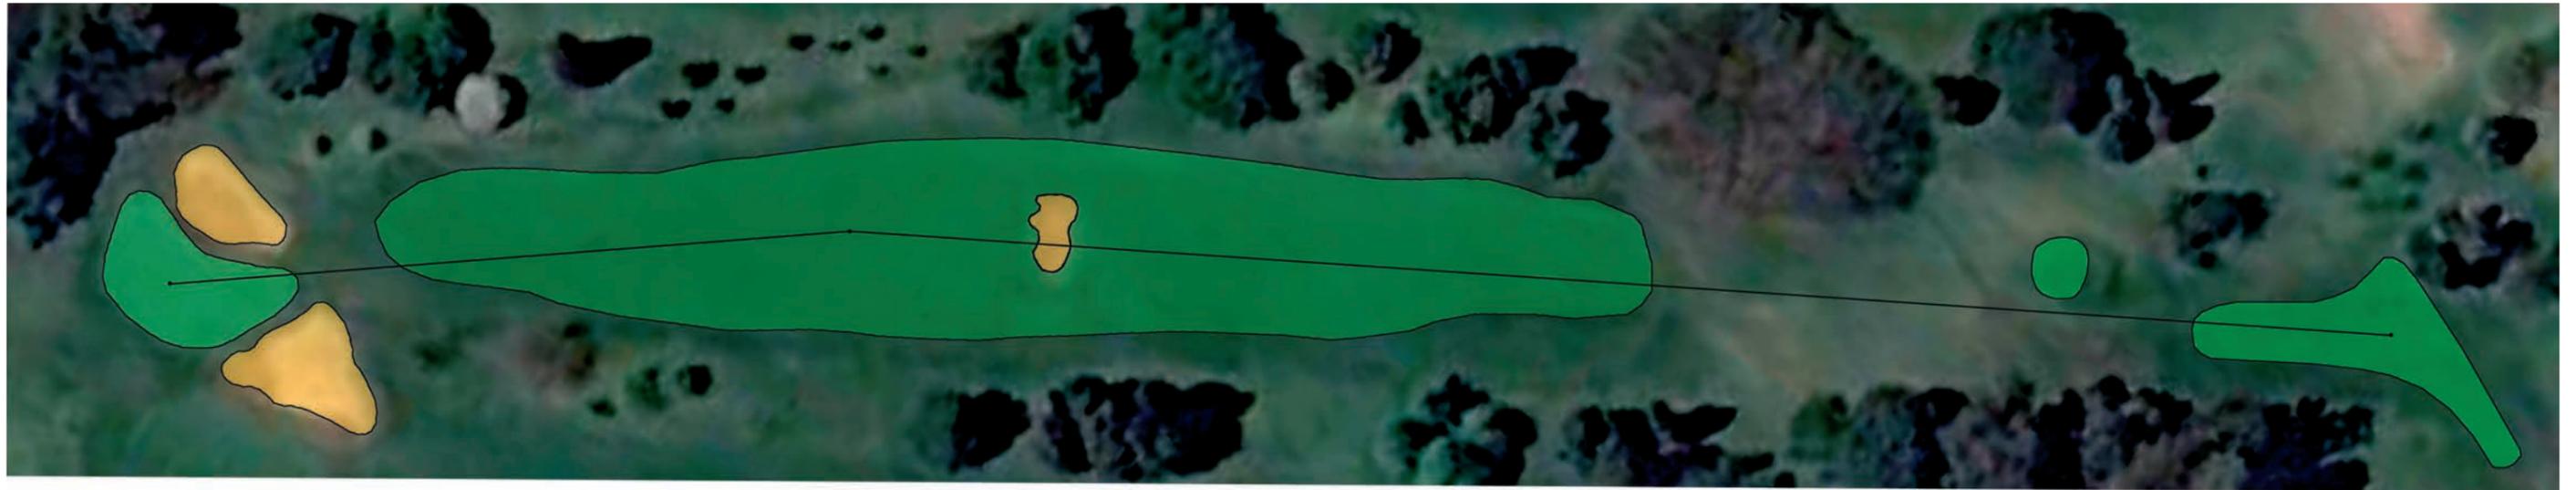
EXISTING

On this hole the concern was the positioning of the existing bunker in the middle of the fairway, that was penalizing the high handicap player. We propose to modify the hole by making it much more strategic in its design. Rather than just having to carry a cross bunker as at present, we wish to privilege risk/reward and positioning. The ideal line of play is as indicated with the proposed center line which permits a much easier second shot to the green totally open from that angle. To play that line the golfer will need to flirt with the left hand side bunker and optically he will be led to think that he must carry the right hand side bunker. The ideal drive will reward the player with an easy second shot. If on the other hand the player wishes to be cautious, he will need to be just short of the left hand side bunker. This will leave him with a more difficult second shot, as the green will be protected by an existing bunker that we propose to enlarge so as to discourage the run up shot. The proposed strategy will also be enhanced according to the various pin positions.

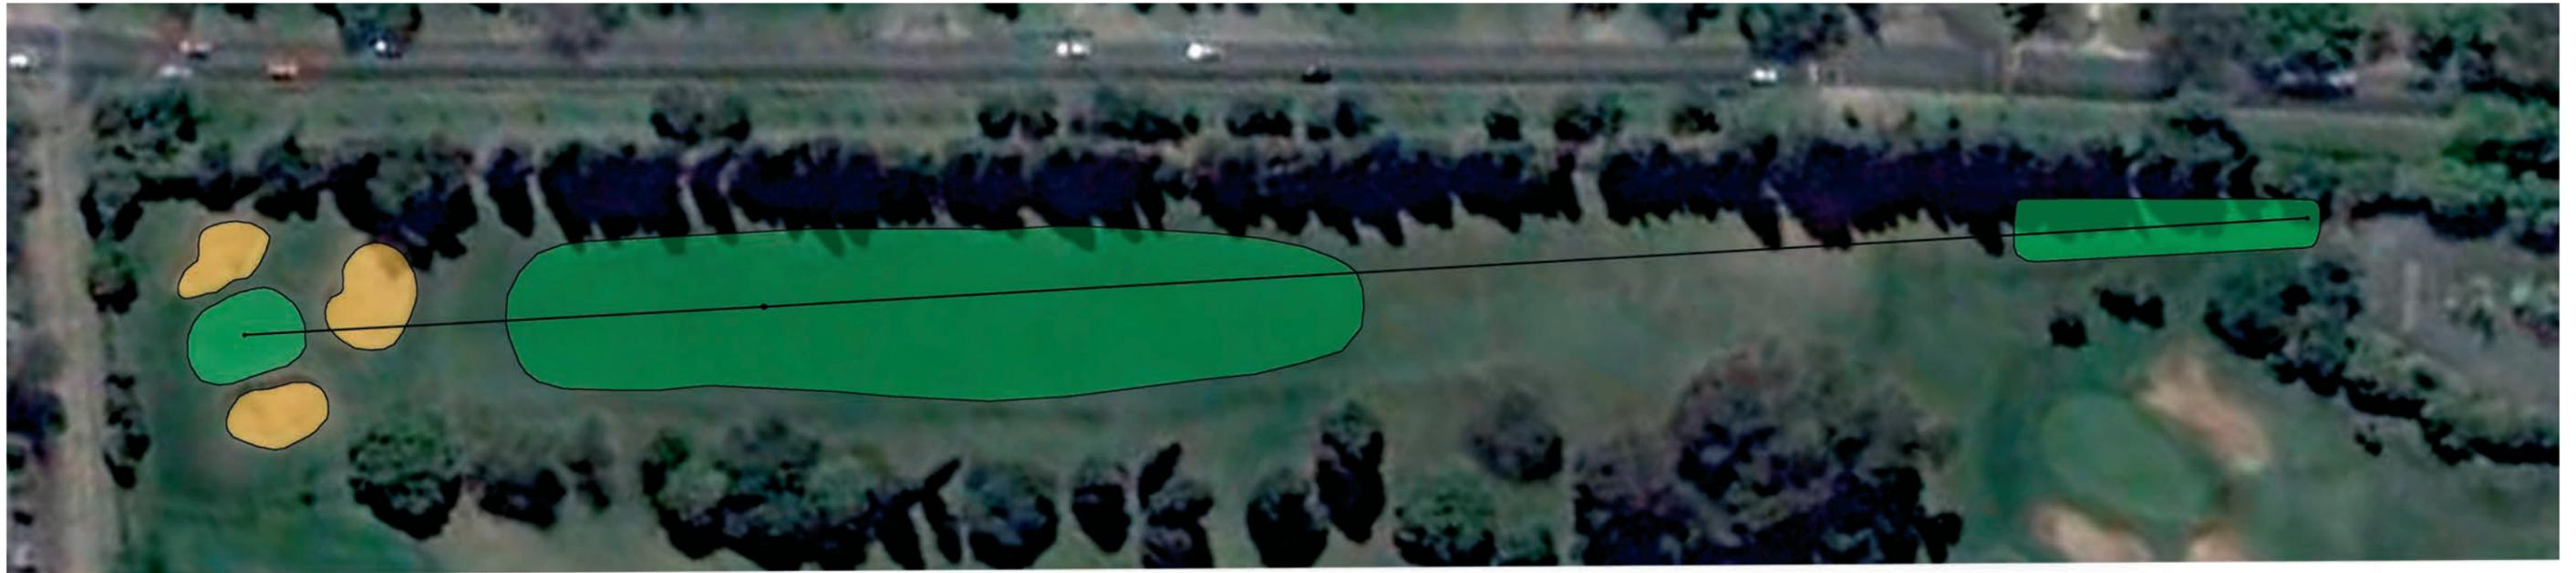
HOLE N° 11
EXISTING

On this hole the major concern was the number of balls going onto the road. In order to help remedy this situation, we propose to shift the center line towards the left hand side and to enlarge the fairway on the left hand side. To reinforce this line of play we propose the positioning of a fairway bunker on the right hand edge of the fairway. This will be a visual maker for the players and will help them line themselves up. With regards to the existing tee box, we propose to re-align it with the proposed center line. As with hole number 4, we propose that some dense planting be put in place alongside both the existing men's and ladies tees. The positioning of this vegetation as the ball rises from the tee rather than at the end of its flight has been shown to be more effective both physically and psychologically.

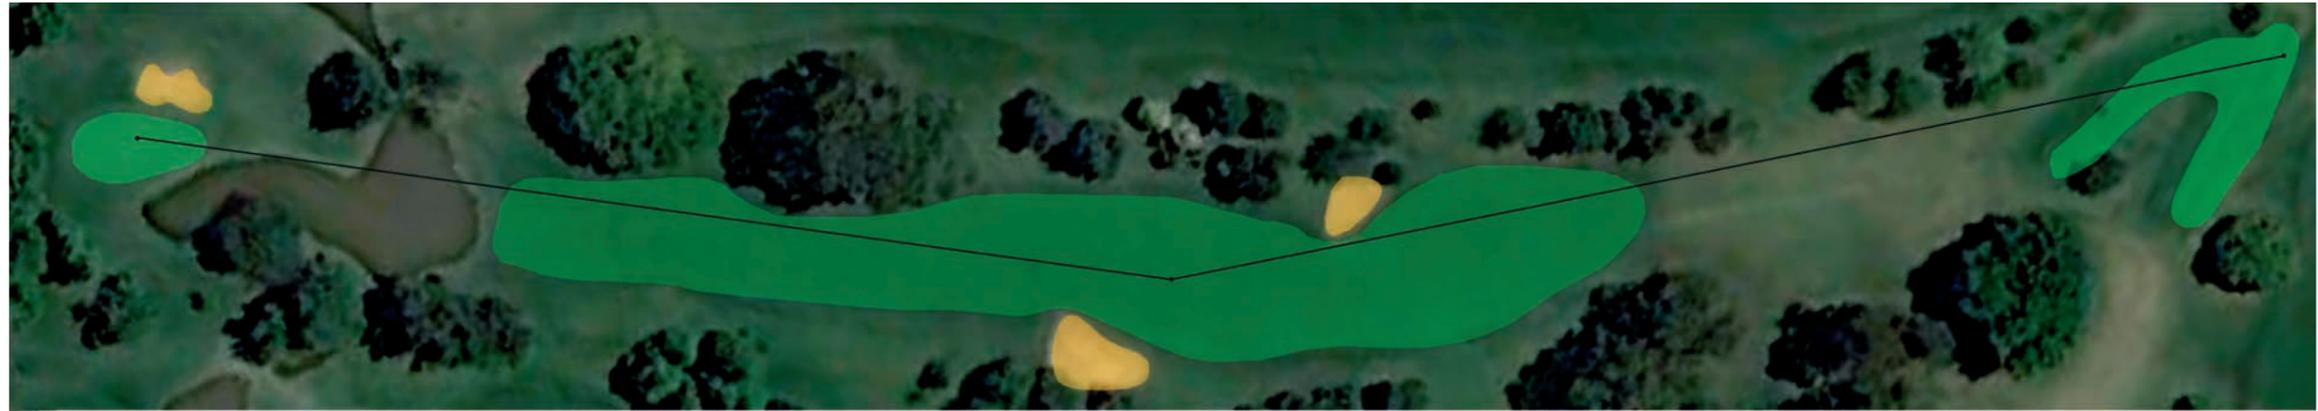
EXISTING

On this hole there were two concerns. The position of the tee box and excessive shade on the right hand side of the fairway in the winter time, making for very poor turf quality. We are proposing that you modify the tee position, similar to the one you are presently using for championship play and fill in the triangle to have a larger teeing surface. With regards to the shade problem, we are proposing to remedy the situation by introducing a new line of play for the lay up shot by positioning a bunker on the right hand side of the fairway and enlarging the fairway on the left hand side. This will privilege positioning, as the best line of play is to flirt with the bunker. The further left you are, the more difficult the approach to the green becomes. The advantage of this proposal is that we can begin with the bunker being a certain size and enlarge its size if turf in proximity is still very poor. It also means that you don't have to maintain this very difficult area. With regards to the trees that are creating the shade problem, I propose a gradual approach. Firstly to build the bunker and see how the situation evolves. If the situation isn't satisfactory then either extend the bunker or start removing a certain number of branches. This has to be done in the field taking into consideration the new proposal for hole n°4 and safety. With regards to the eucalyptus trees on the right hand side rough, I propose that the thinnest tree be removed, and that the thinning out be done in the field once we can clearly visualize its impact, at the beginning of your autumn season.
